WL-TR-97-2053

THIN DENSE CHROME BEARING INSERTION
PROGRAM

GE AIRCRAFT ENGINES
ADVANCED ENGINEERING PROGRAMS DEPT
ONE NEUMANN WAY
CINCINNATI OH 45215-6301

FINAL REPORT FOR 03/01/92-12/01/96

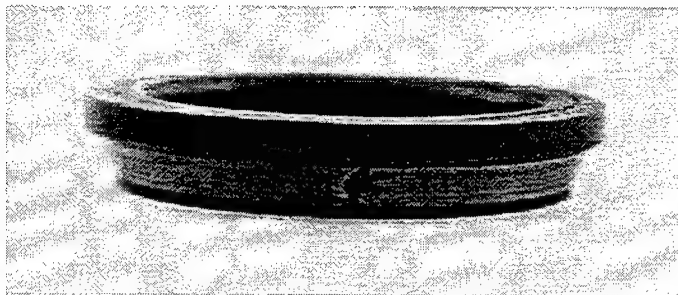
Two baseline (bare M50) failures occurred, one at 620 hours and the other at 4,030 hours. Five TDC coated bearings failed at 41, 225, 1,825, 2,293, and 2,710 hours. All failures were inner ring spalls. The estimated L10 calculation for the population based on this experiment was 2,943 hours for the baseline bearings and 519 hours for the TDC coated bearings. The TDC coated bearings L10 life clearly appeared inferior in RCF to the unplated baseline bearings. Figures 89 through 95 show both the failed baseline and TDC coated inner rings from this round of testing.

Figure 92. Photo of TDC Coated Bearing Spall Which Failed at 1,825 Hours.
One of five failures.

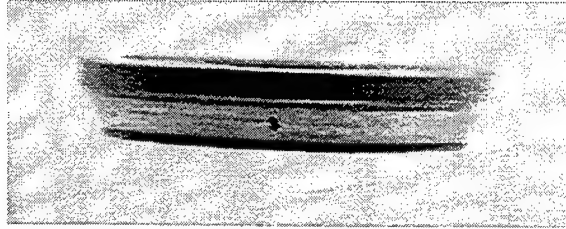
Surface roughness measurements of the inner race ball track indicated its preplate roughness was approximately $2.0\text{ }\mu\text{in}$, while its roughness postplating was on the order of $4\text{--}5\text{ }\mu\text{in}$. This corresponded to an initial Lambda around 1.2 to 1.8 for the plain bearings, and around 0.7 for the TDC coated bearing. As in the MRC bearings, this explains why the ball track in the plain bearings was so difficult to see, while they are

quite easily found in the TDC coated bearings. Again, it is generally accepted that the fatigue life difference between a bearing with a Lambda of less than 1.0 and one in which it is greater than 1.5 can be very substantial, since the low Lambda ratio bearing is much more prone to surface distress which can lead to early fatigue.

Figure 93. Photo of TDC Coated Bearing Spall Which Failed at 225 Hours.
One of five failures.

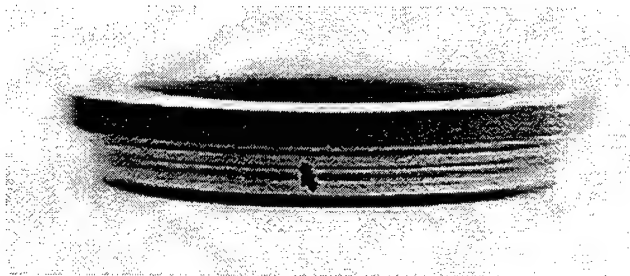
Figure 94. Photo of TDC Coated Bearing Spall Which Failed at 2,710 Hours.
Only TDC failure over 2,500 hours.

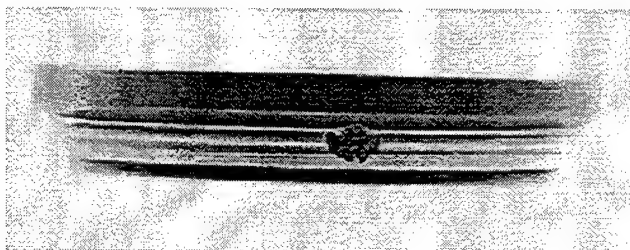
Figure 95. Photo of TDC Coated Bearing Spall Which Failed at 2,293 Hours.
One of five failures. Note easy to see ball track. The L10 of the TDC coated bearing was 1/6th that of the bare bearings.

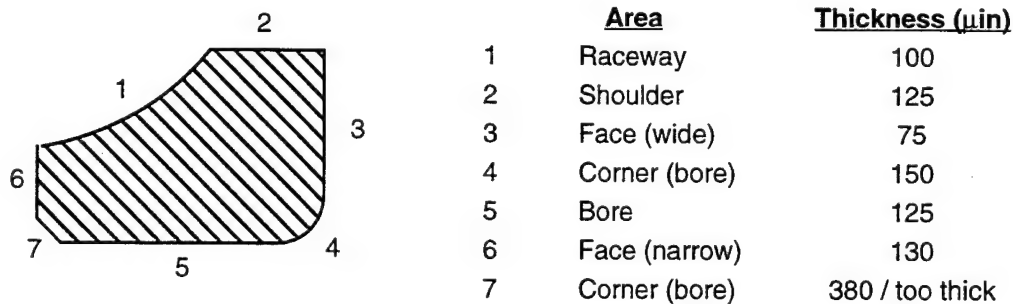
Figures 96 through 104 show the TDC coatings of these seven areas. Note that area number seven, the bore corner, contained TDC with a thickness of 380 μ in, which is greater than the 250 μ in maximum allowed in the GE Specification. Examination of **Figure 104** also shows what appears to be microcracks running through the TDC coating. This condition is not evident in the thinner coating areas.

Figure 96. TDC Plating Thickness Measurements. Area 7 was the only measurement above the max. spec. thickness of 250 μ in.

Corrosion testing was performed by Dirats Laboratories. The test ring exhibited isolated areas of rust spots after the 24-hour salt spray test. Additional testing was performed using an acidified copper sulfate to determine the presence of exposed iron. Areas of the bore to abutting face chamfer (Area 7 in Figure 96) and the shoulder exhibited a copper color after six minutes in the solution, indicating exposed iron. One of the corner areas adjacent to the corroded zone appeared to be delaminated. **Figure 107** shows the corrosion pits as a result of the salt spray test. Appendix D contains a certification report of this test.

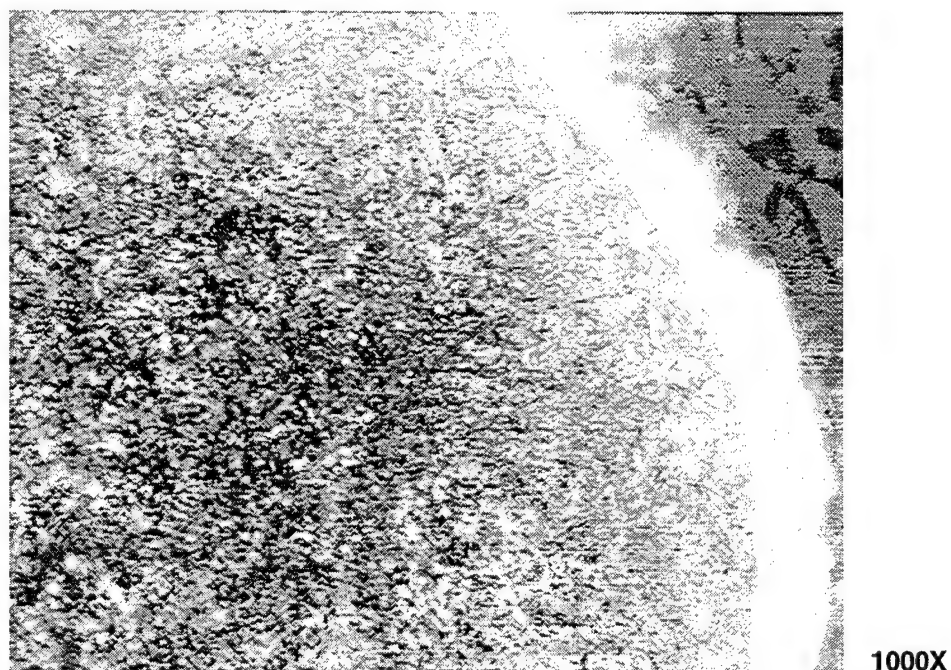
Figure 103. Optical Photomicrograph of Bore Corner (Area 7) 380 μ in TDC Thickness.
Above specification maximum of 250 μ in.

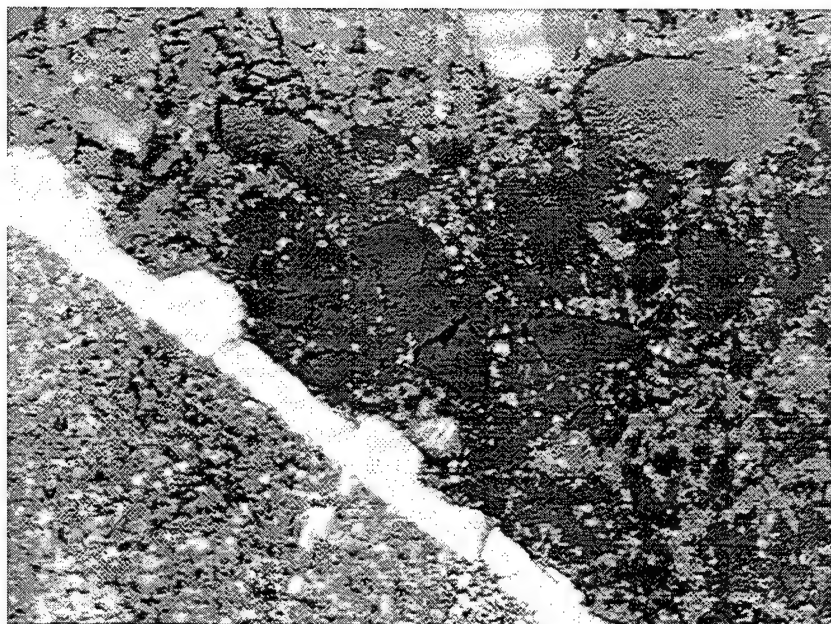
1000X

Figure 104. Optical Photomicrograph of Bore Corner (Area 7) 380 μ m TDC Thickness.
Above specification maximum of 250 μ m, note cracks in TDC plating.

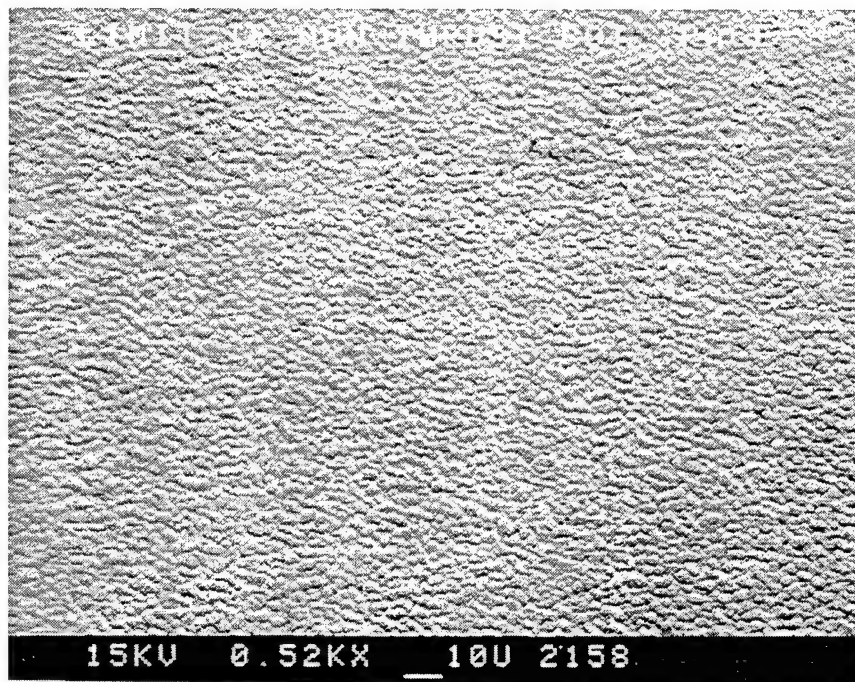
520X

inspection at 500X revealed a proper looking nodular texture, as can be seen in **Figures 105 and 106.**

Figure 105. SEM Photomicrograph of the Raceway Bottom Surface Texture.
Within specification.

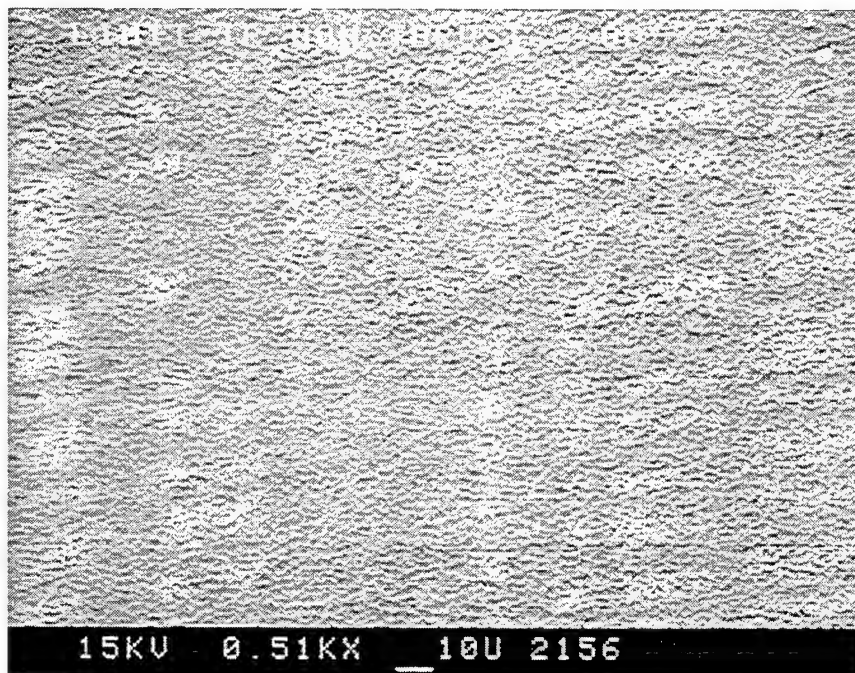
510X

Figure 106. SEM Photomicrograph of the Outside Diameter Surface Texture.
Within specification.

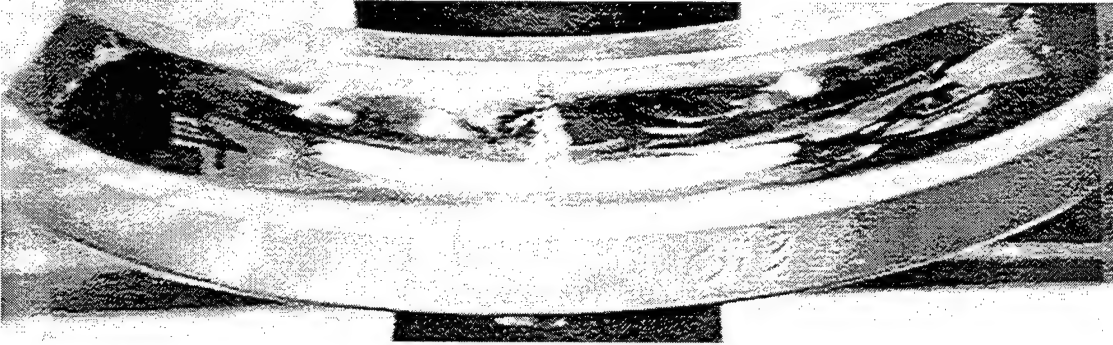
3.5X

Even with the modification to the load application rates, failures of the baked TDC bearings occurred at 246, 501, 710, 1,002, and 1,193 hours, with one group being suspended at 2500 hours. This results in an estimated population L10 life of 595 hours, which is very similar to the L10 of 519 hours exhibited by the TDC coated bearings in Round 1. All of the failures

were consistent with Point Surface Originated (PSO) failures, indicating that the TDC coating in a relatively low Lambda bearing may actually degrade the bearings surface integrity and its RCF life.

Figures 108 through 112 show the spall failures in the baked TDC plated bearings. SEM examination of the failed bearings revealed that most, if not all, were again surface originated failures. Further examination on the SEM revealed areas just ahead of the spall origination point of distressed TDC, indicated by the white arrows in **Figures 113 through 115**.

Figure 108. Photo of TDC Coated Bearing Spall Failure at 1002.7 Hours.

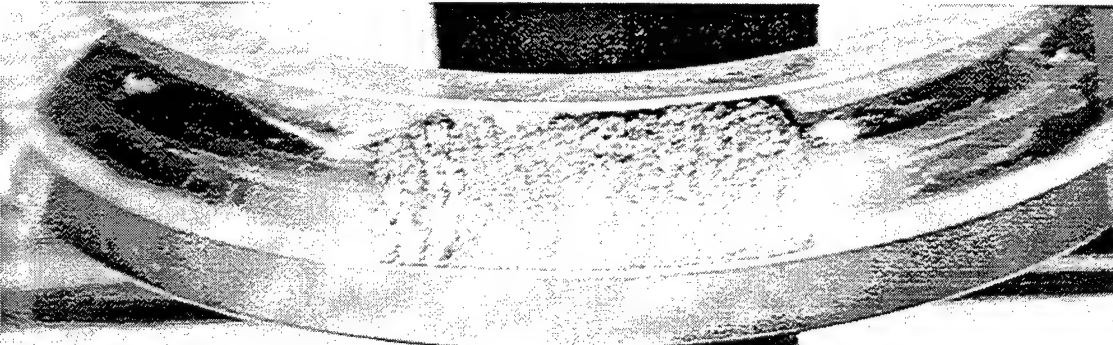
3.5X

Figure 109. Photo of TDC Coated Bearing Spall Failure at 1193.3 Hours.

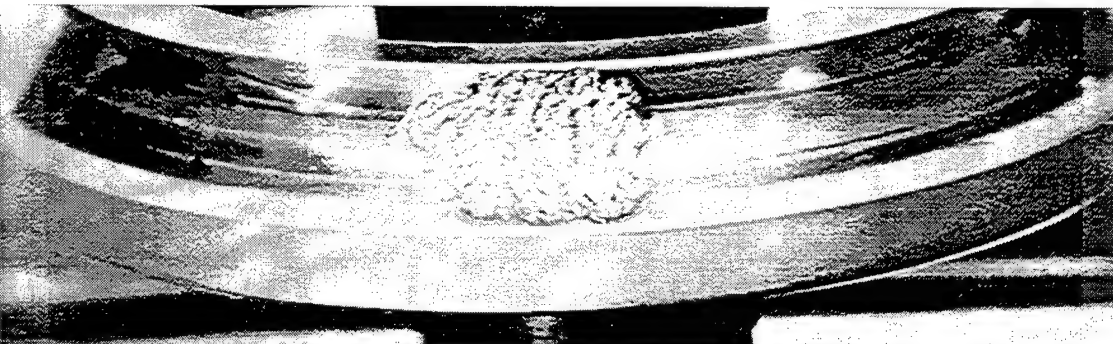
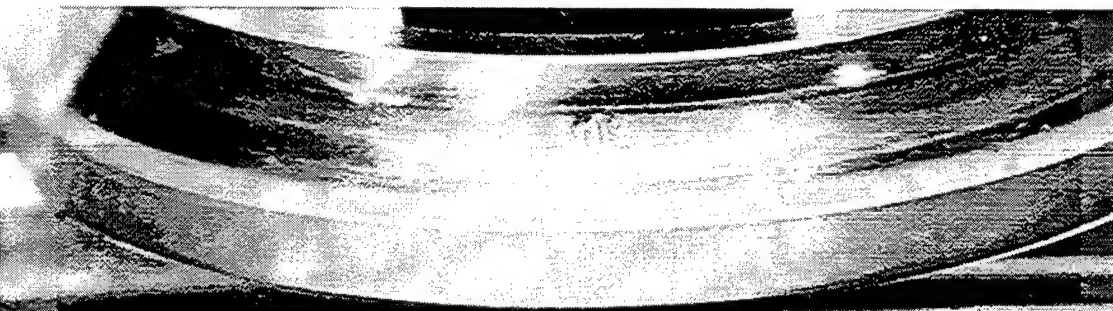
Figure 110. Photo of TDC Coated Bearing Spall Failure at 246.6 Hours.
Bearing had both large and small spalls.

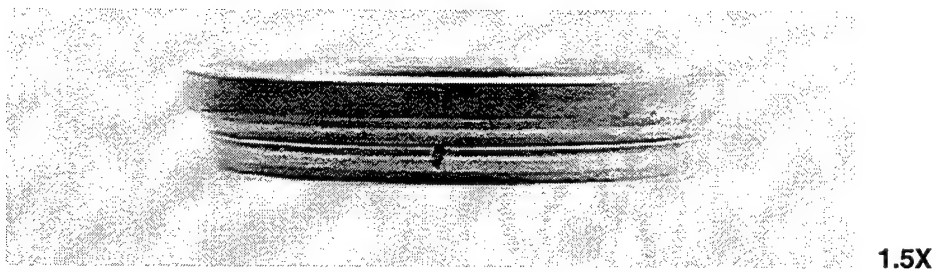
Figure 111. Photo of TDC Coated Bearing Spall Failure at 500.8 Hours.

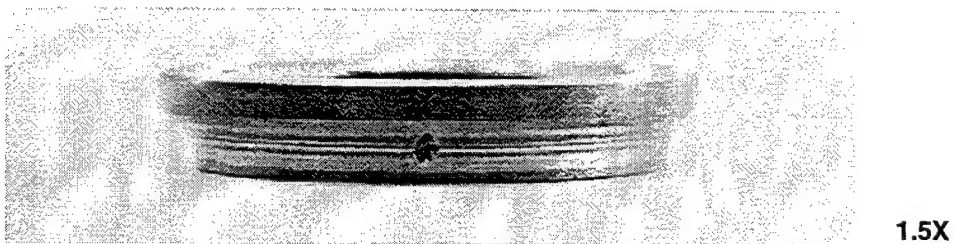
The contact ellipse of an angular contact bearing contains elements of rolling, sliding, spinning, and gyroscopic motion. It is the sliding, spinning, and gyroscopic motions which is suspected of causing the TDC distress and subsequent bearing failure, particularly if the Lambda ratio is low.

Figure 112. Photo of TDC Coated Bearing Spall Failure at 710 Hours.
The L10 of the TDC coated bearings was approximately 1/6th that of the plain bearings. A major concern exists in the application of TDC in low Lambda regions.

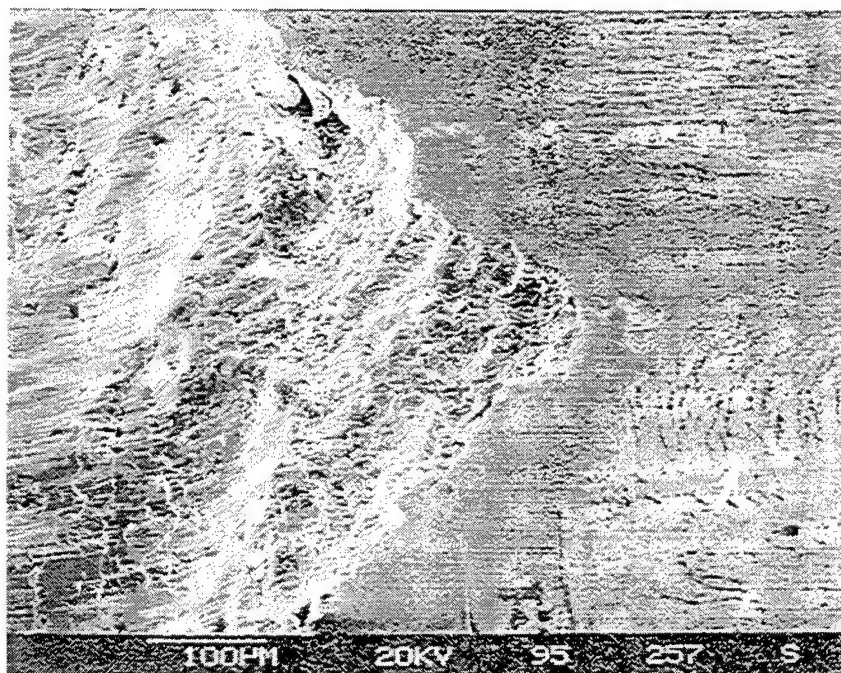
160X

Figure 115. Photomicrograph of S/N 0027 Inner Race Showing Distressed TDC Ahead of Point Surface Originated Spall.

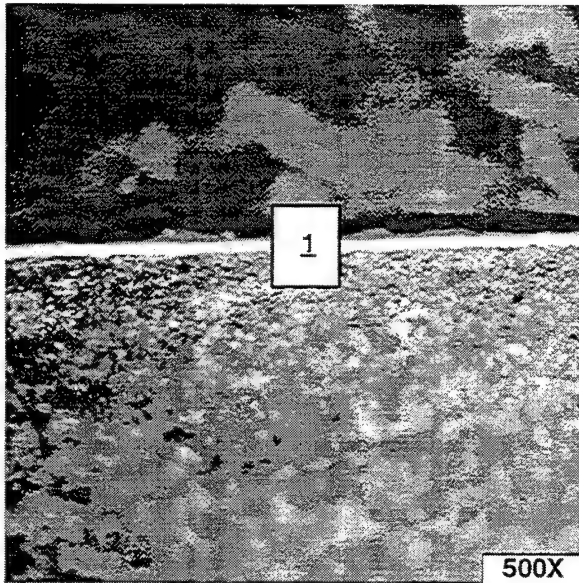
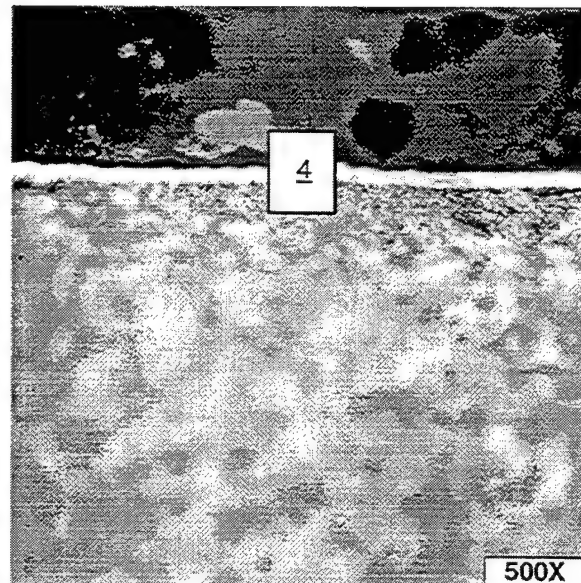
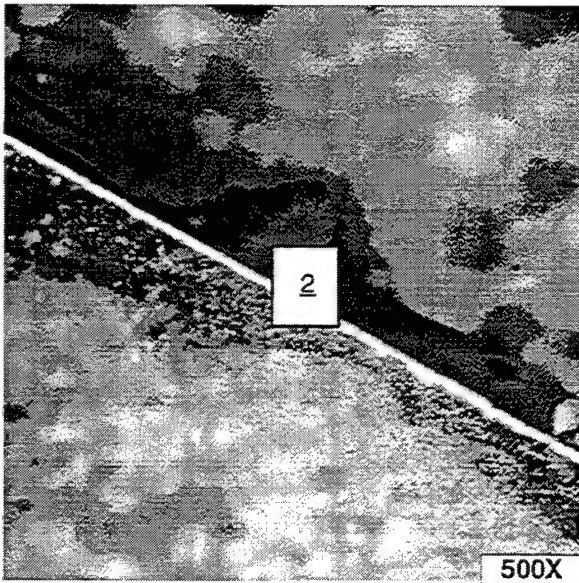
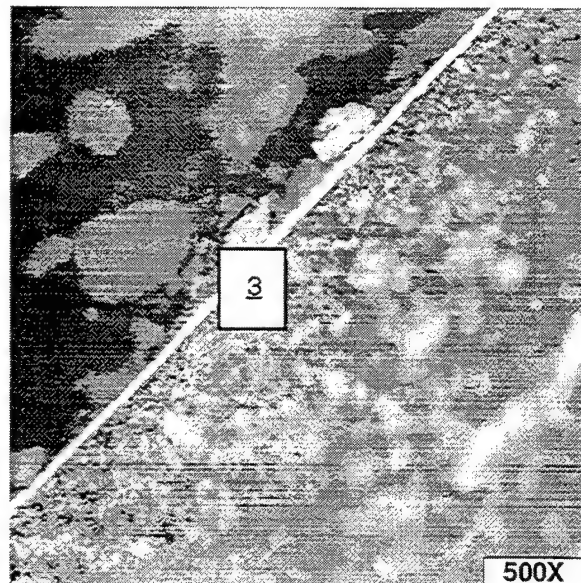
All six bearings successfully completed the required 2,000 hour testing. **Table 19** summarizes the results of this test. Posttest inspection results indicated that the TDC remained intact in the raceway ball tracks. **Figure 116** illustrates a typical bearing outer race condition after 2,000 hours of testing. No evidence of TDC coating distress was found on any of the bearings during posttest inspections.

Figure 116. Photos of Bearing S/N MABS9636 After 2,000 Hour Operational Endurance Test.
TDC passed test.

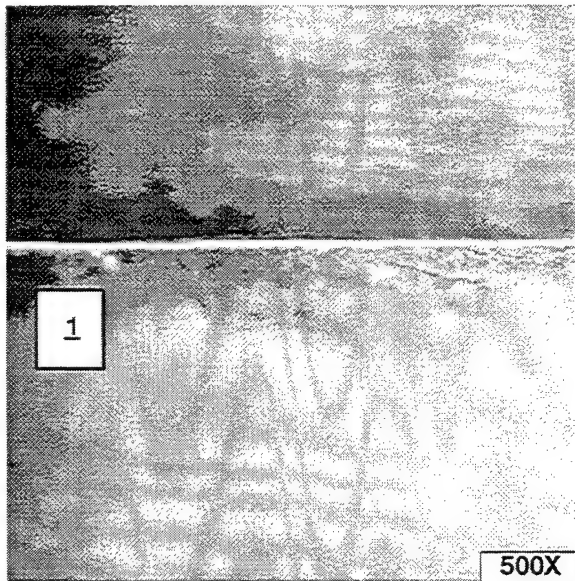
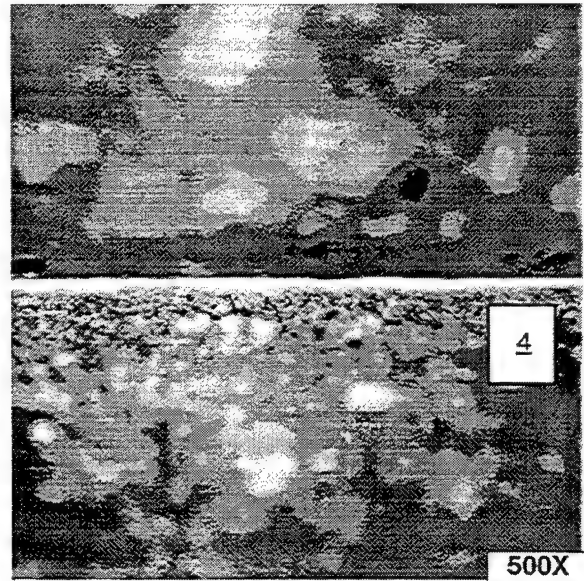
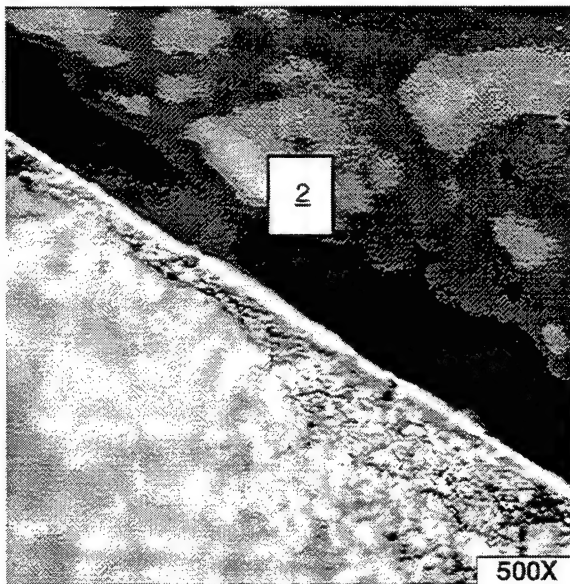
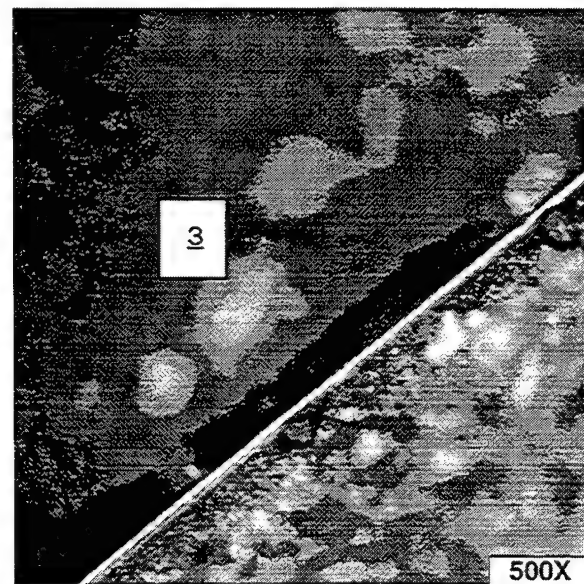
The second test was completed with two TDC coated M50 bearings. Both bearings successfully completed the required 1,000 hours of testing. Posttest inspection indicated that the TDC remained intact on both bearings. **Figure 119** illustrates the acceptable condition of the TDC coating after test.

Figure 119. Photos of Contamination Tested TDC Bearing S/N MDACE705 After 1,000 Hours.
TDC coating integrity demonstrated in contained environment.

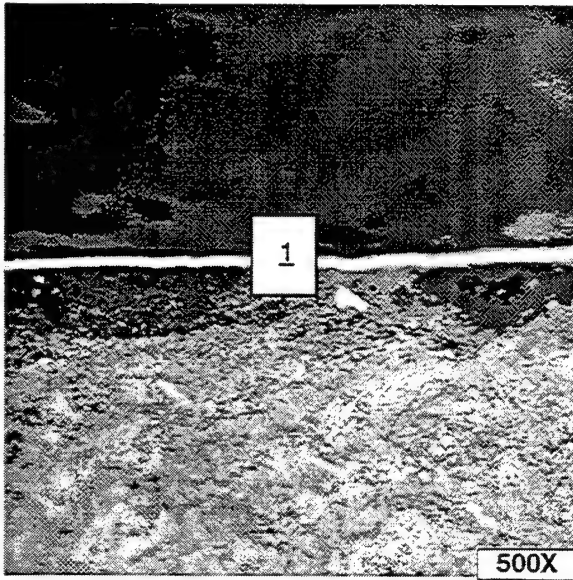
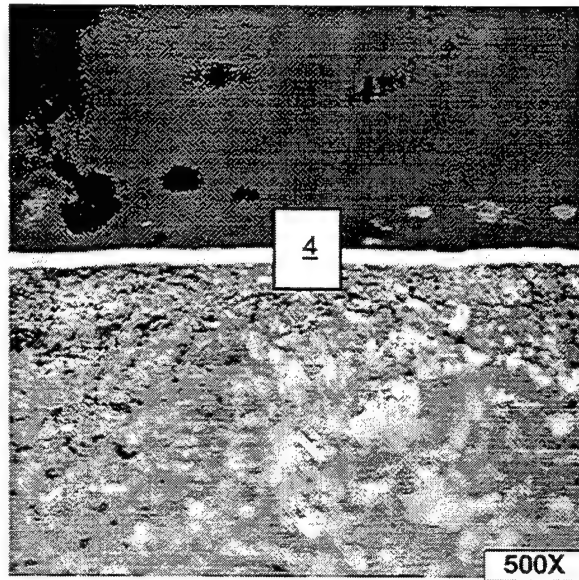
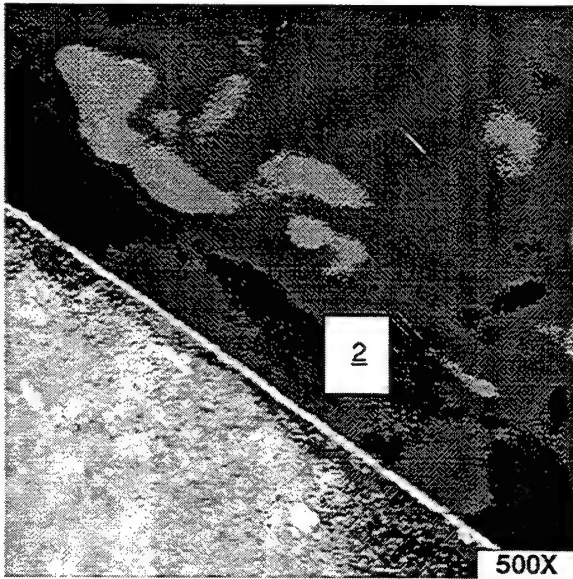
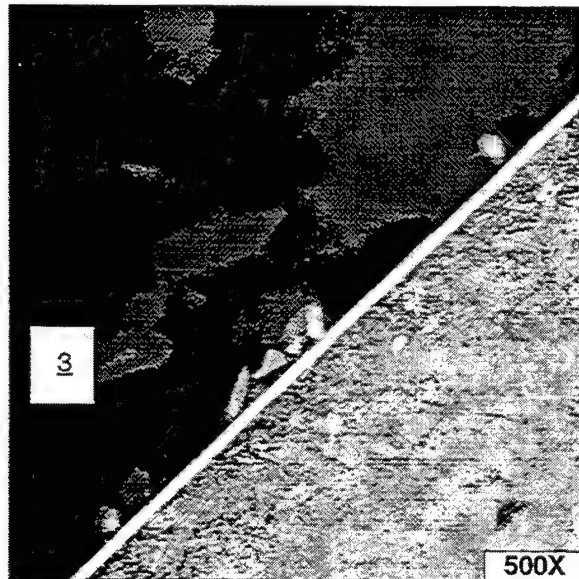
The TDC coating successfully adhered to the base material and did not demonstrate any evidence of distress resulting from oil-off testing. **Figure 121** is a photograph of a typical TDC coated bearing outer race after testing, illustrating the acceptable condition of the coating.

Figure 121. Photos of Off-Oil Tested TDC Bearing S/N MDACE694.
TDC coating demonstrated acceptable off-oil performance.

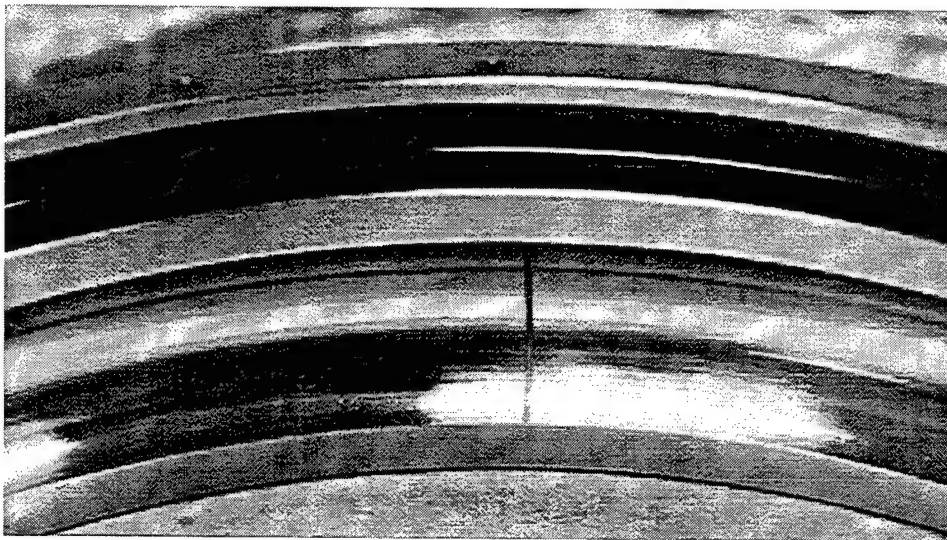
EDM Groove in Plain Outer Race
P/N 9732M10P16
S/N MDA605JV

A total of four bearings completed induced defect testing. Two TDC coated and two plain bearings were tested to compare the relative times from spall initiation to cage fracture. A 0.020 inch wide by 0.010 inch deep groove was machined across the entire raceway of each outer ring using an EDM process. **Figure 124** shows photographs of typical grooves in the raceways prior to test.

Figure 124. Photos of EDM Groove Machined in Outer Race for Induced Defect Test.

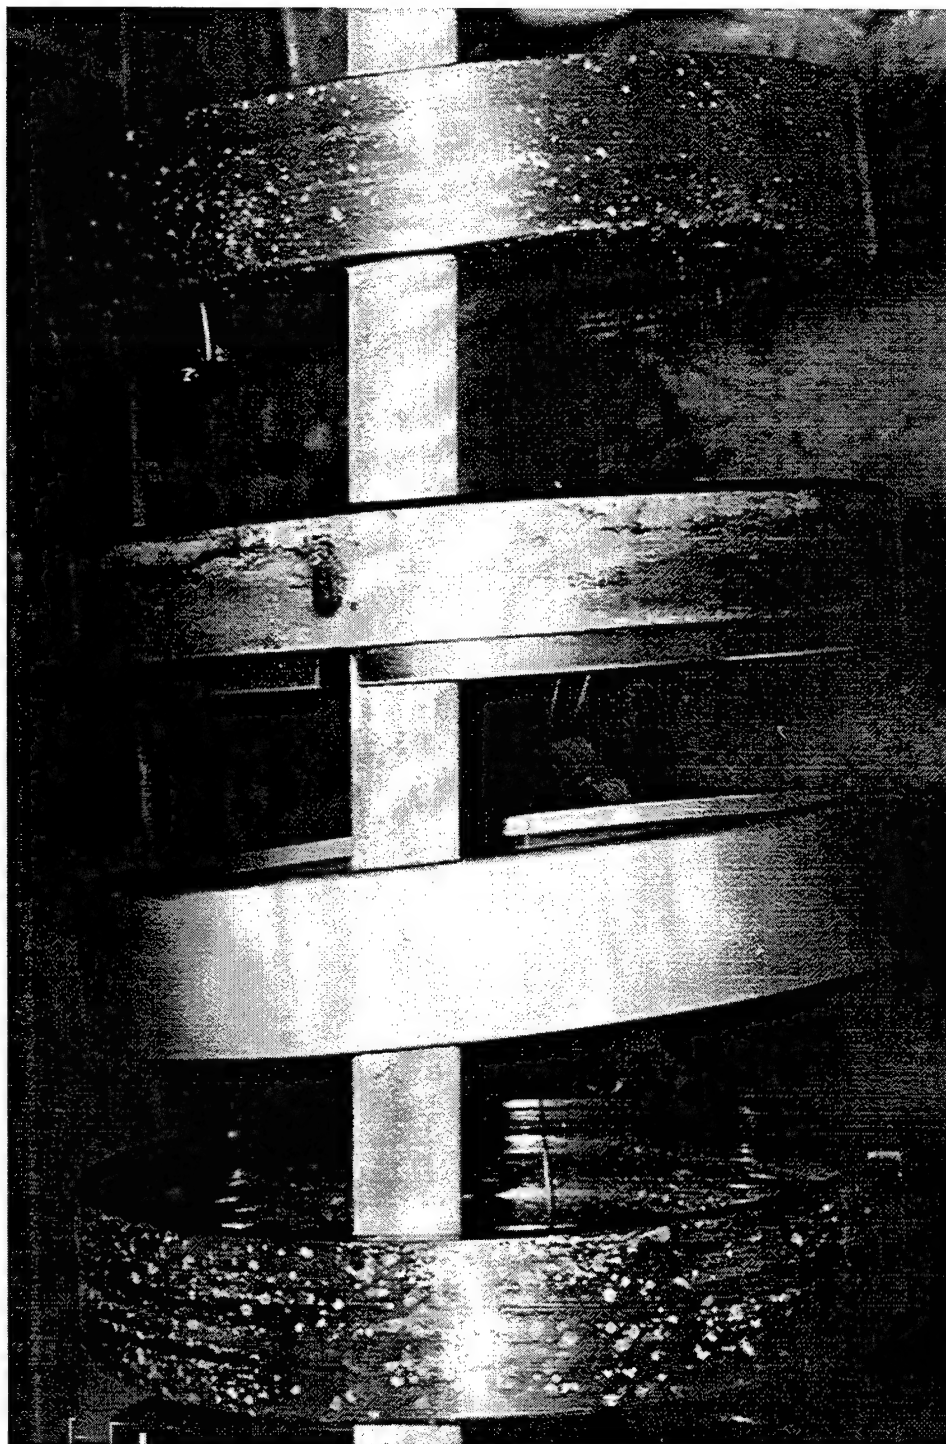
Figures 127 and 128 illustrate the conditions of the test races after atmospheric exposure. As evidenced by these photographs, the TDC coating provides a significant increase in corrosion resistance compared to plain bearings.

Figure 128. Photos of Corrosion Resistance Test Bearings.
TDC coating significantly improved corrosion resistance.

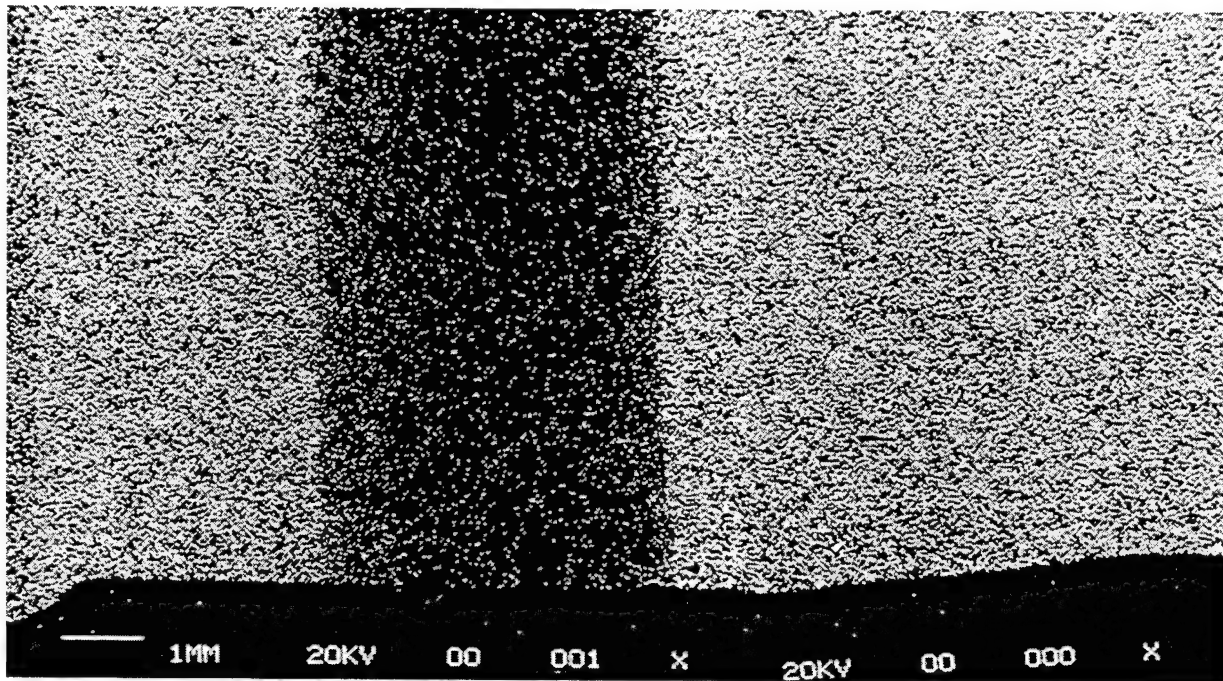
10X

The No. 3B bearing experienced skid damage which resulted in removal of the TDC in the skid affected area of the race and spalling of one ball. Figure 132 is an energy dispersive spectroscopy dot map of the raceway ball track

looking for chromium. TDC had been removed as indicated by the dark band in this photograph. Figure 133 is a SEM photograph of the spalled ball. Spalling originated at the surface, probably as a result of the skidding action which damaged the TDC coated race.

<u>Bearing</u>	<u>Total Test Time</u>	<u>Inspection Results</u>
#1R	813 Hours	Acceptable
#2B	813 Hours	Acceptable
#3B	813 Hours	Not Acceptable; Skid Damage; Ball Spall; TDC Removed in Skid Areas of Race
#4R	281 Hours	Acceptable
#5R	281 Hours	Not Acceptable; Partial Peeling of TDC on Inner Race

Figure 132. Energy Dispersive Spectroscopy of F110-GE-129 ESN 538-103/4 No. 3 Bearing.
Dark band in the center of the dot map indicated the TDC has peeled away. TDC coating is susceptible to operational skid damage.

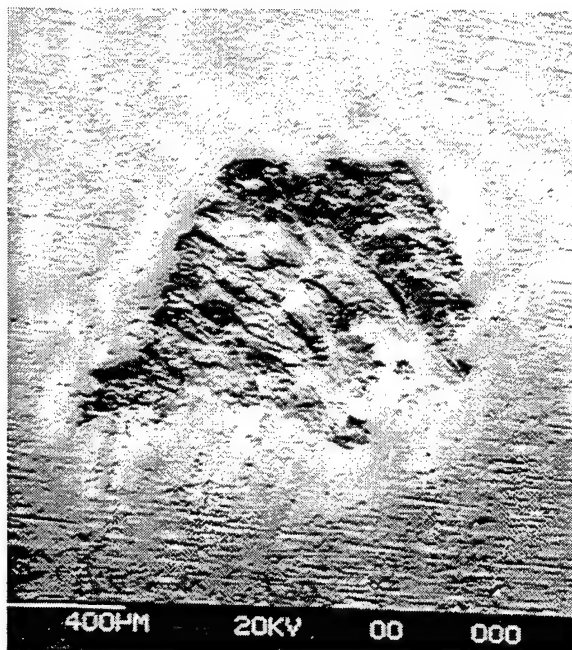
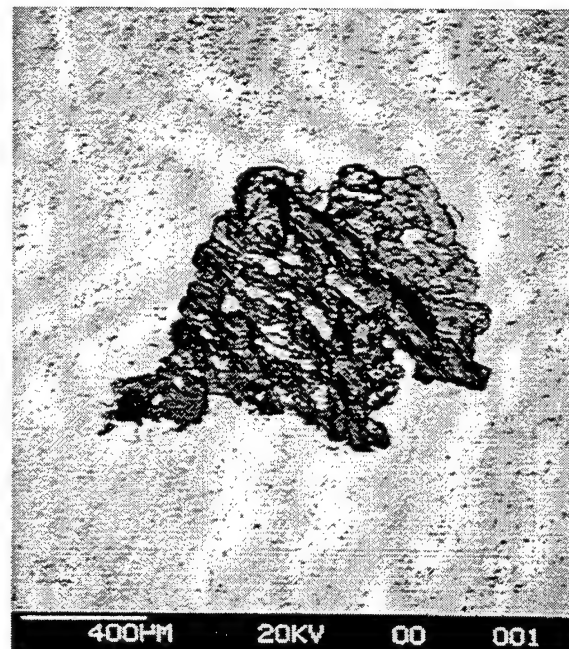
Figure 133. SEM Secondary and Backscatter Photos of Ball Spall.
Skid damaged TDC coating initiated ball spalling in test of ESN 538-103/4 bearing.

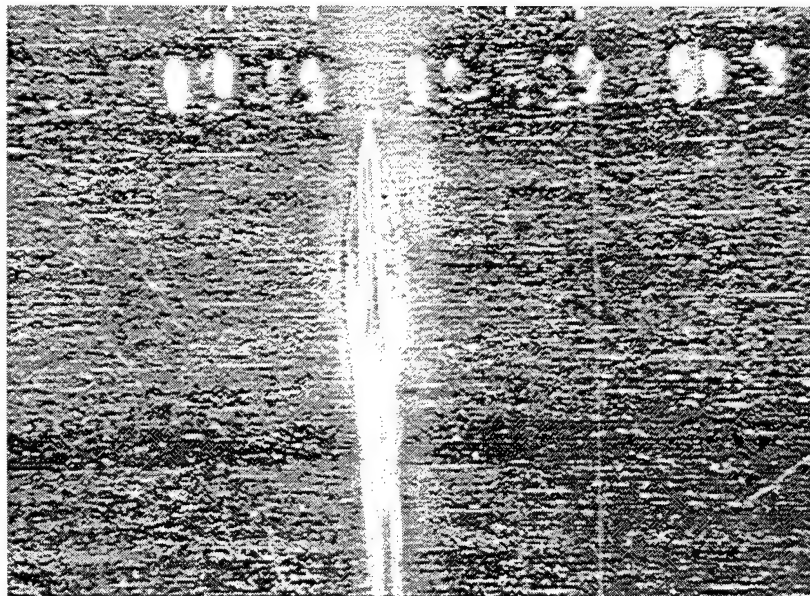
20X

The axial scratches breach the TDC coating and extend into the base M50 material. These scratches were caused by damage during engine assembly when the TDC coated rollers axially slide against the TDC coated race. The circumferential ring of dents was probably caused by raised material on the rollers (transferred from race). Localized TDC peeling was considered secondary damage due to continued operational forces at the edges of the dents. **Figure 135** is a photograph of a typical axial scratch and the adjacent dents.

Similar to previous rig and engine test results, these test results indicate the TDC coated bearings are susceptible to roller bearing assembly damage and ball bearing skid damage.

Figure 135. Photo of F110-GE-100 ESN 509-716/5 No. 1R Bearing Inner Race Scratch/Dents. *TDC coating roller bearings demonstrated reduced assembly damage resistance.*

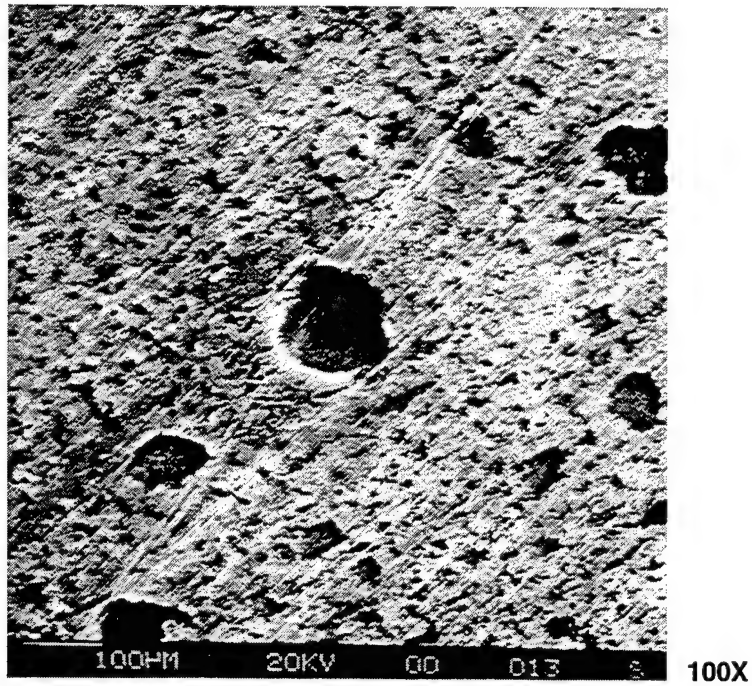
The posttest condition of the No. 2B bearing was considered marginal. Although the condition of the bearing was within inspection limits, there was evidence of undesirable skid damage on the inner race. A circumferential ring of partially peeled TDC areas was present in the location where skidding is likely to occur. **Figures 137, 138 and 139** are SEM photographs of these areas. **Figure 139** highlights a typical area adjacent to a location of partially peeled TDC. Secondary polishing and micro-peeling of the TDC has occurred in these areas.

Figure 138. SEM Secondary Photo of F110-GE-100 ESN 509-716/5 No. 2B Bearing Inner Race.
